Aspects Of Safety And Serviceability Of Heaps With Viscoplastic Materials Due To Man-Made Liners Or Natural Slip-Surfaces

ABSTRACT: The tailings of potash mining are piled up in huge heaps with heights of up to more than 200 m and a ground area of often more than a square km. The material behaviour of the salt is strongly visco-plastic, so that the slopes of the heaps are moving constantly at slow rates. As the strength of the salt is rate-dependent, structural analysis of the slope stability has to consider the deformations and deformation rates and the interaction of subsoil and slope. Due to the complex material behaviour the structural analysis is accompanied by an extensive measuring programme within the Observational Method.

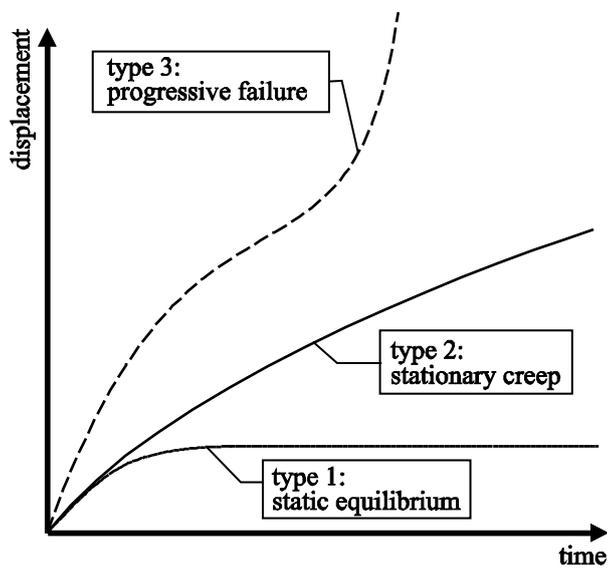
Fig. 1: Time-displacement for time-dependent material behaviour

Structures consisting of materials with time dependent material behaviour show some special features in their load-displacement reaction. Compared to structures with no or negligible time dependent behaviour they may be moving at a constant rate although they are stable (fig. 1). A

collapse of the structure is typically preceded by an acceleration of the movements (type 3 in fig. 1). The time scale in this schematic view varies with the viscosity of the material. For rock salt the typical time scale would be days to weeks.

inclinometer. Both soil profiles showed a heavily remoulded mixture of clay from the base lining, pebbles and rock instead of the base sealing, which had obviously been destroyed by the already large movements. The inclinometer data confirmed the geodetically measured deformation rates and localized the movement to the heavily remoulded base lining (fig. 8). The obvious cause of the observed movements was thus identified as a failure of the base lining, establishing it as a slip surface and causing the western slope to change its balance towards a dramatically higher rate of deformation in the visco-plastic corresponding to type 3 of fig. 1.

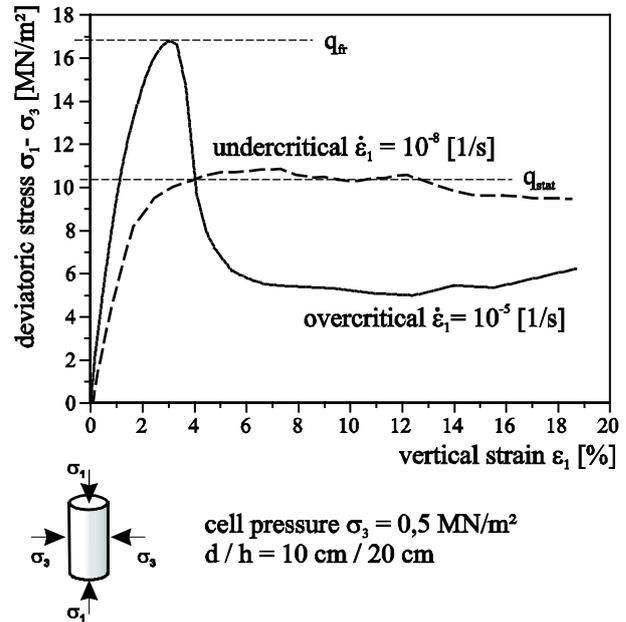
Fig. 2: Typical triaxial tests on rock salt

The strength of rock salt depends on both the stress level and the deformation rate. Similar to the higher bearable deviatoric stresses at a higher stress level, bearable deformation rates increase with increasing stress level. This behaviour is illustrated in figure 2: The results of two strain driven triaxial tests on rock salt at different strain rates are given. The cell pressures in both specimens are the same, whereas the strain rates vary by the factor 1000. The specimen with the higher strain rate of $d\varepsilon_1/dt = 10^{-8} \text{ 1/s}$ shows the typical behaviour of a dense granular material: It reaches a peak strength q_{fr} followed by a decrease in bearable deviatoric stress and macroscopic failure with a deterioration of the specimen. The second specimen was submitted to the same strains at a substantially lower strain rate of $d\varepsilon_1/dt = 10^{-5} \text{ 1/s}$. At this rate the specimen does not show macroscopic failure but creeps at a constant stress

level q_{stat} . With reference to the different observed behaviour, the strain rates are called overcritical or undercritical respectively (Boley 1999).

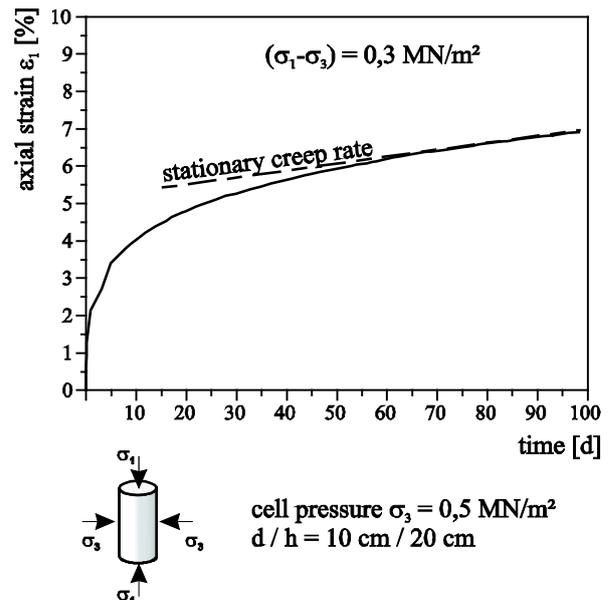
Fig. 3: Typical creep curve of rock salt

Creep is driven by stresses. Submitted to a deviatoric stress state, rock salt begins to creep at an initially high rate, slowing down asymptotically to a constant rate which is called the stationary creep rate ε_{cr}^{stat} (fig. 3). At this rate micromechanical creep mechanisms (dislocation creep, diffusion creep) take place, allowing the specimen to bear large strains without macroscopic failure.

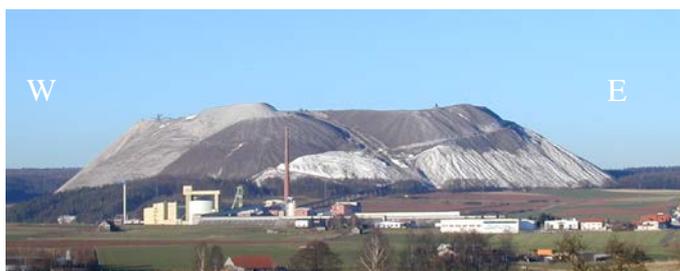
Fig. 4: View on tailing heap

The first example deals with a 190 m high heap, which covers a ground area of >1 km² (fig. 4). It is situated in the German highlands. Dumping is performed at a yearly dump rate of about 2 Mio tons from the top of the heap. This dumping process lets the heap grow laterally at a constant height.

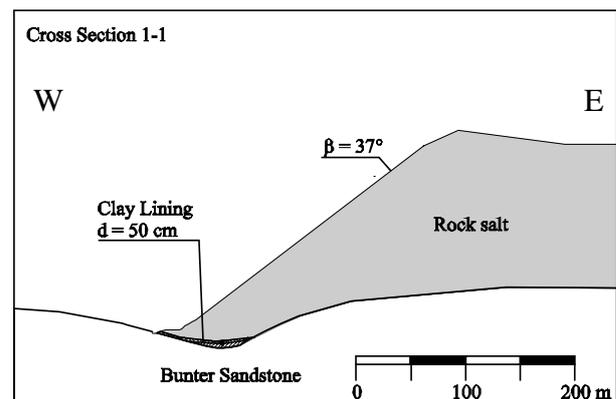
Fig. 5: Cross section

At the time when the large displacements were observed first, dumping was performed on the western slope. Figure 5 shows a cross section of the western slope with a slope angle of approx. 37°. The western slope at that time followed a valley leading to NE. The height of the eastern slope of the valley is approximately 50 m with the steepest part near the bottom of the valley. The base sealing is situated in the bottom of the valley,

consisting of a 50 cm thick mineral lining and a drainage layer of gravel. The base sealing is shown in light grey in the ground view (fig. 5).

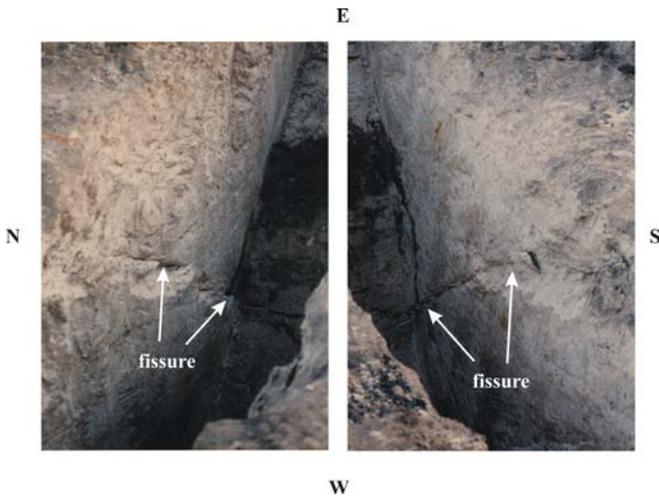
Fig. 6: Fotos of the test pit including fissures

When large deformations of a dewatering ditch surrounding the heap indicated a possible movement in 1997, an extensive measuring programme was started to verify the observations and identify possible causes. Further investigations showed cracks on the top of the heap and fissures on the sides of the test pit (fig. 6), indicating a failure surface. The following measuring programme was carried out:

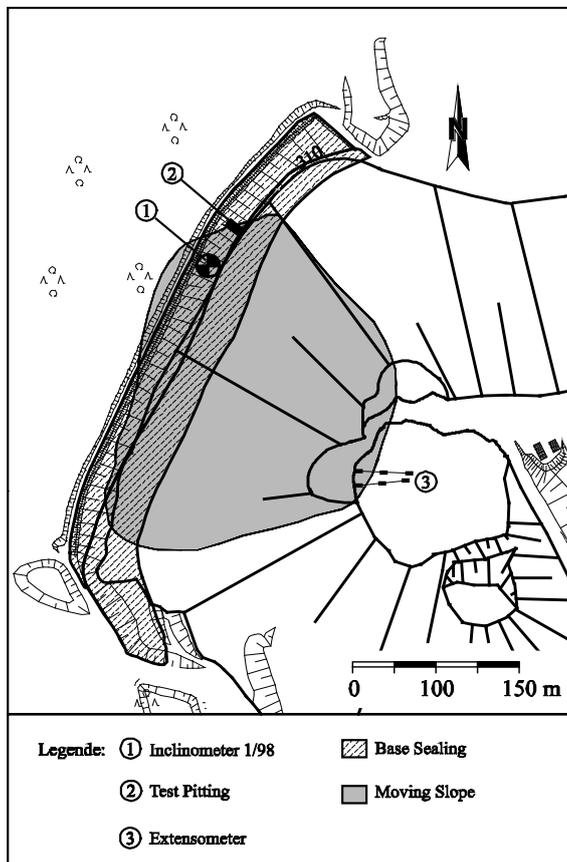
Fig. 7: Ground view of the moving slope and the measuring devices

- geodetic measuring of 180 points adjacent to the footing of the western slope,
- two horizontally installed extensometers on

- the top of the heap and
- one inclinometer with a depth of 22 m.

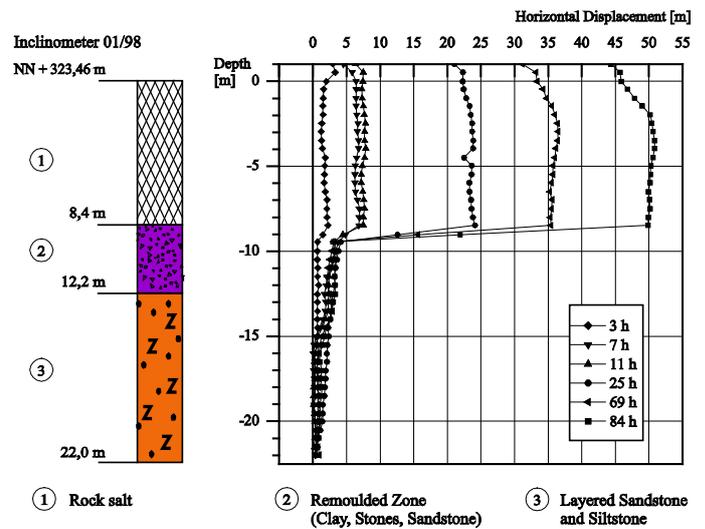
Fig. 8: Inclinometer Measurements

The cause of the observed movements could be identified clearly by the test pitting and the

According to the results of the geodetic measuring devices a major part of the slope moved at a rate of 2 cm/d. The spatial extension of the moving slope could be well defined and is shown in fig. 8. The mass was estimated to approx. 2 Mio. tons.

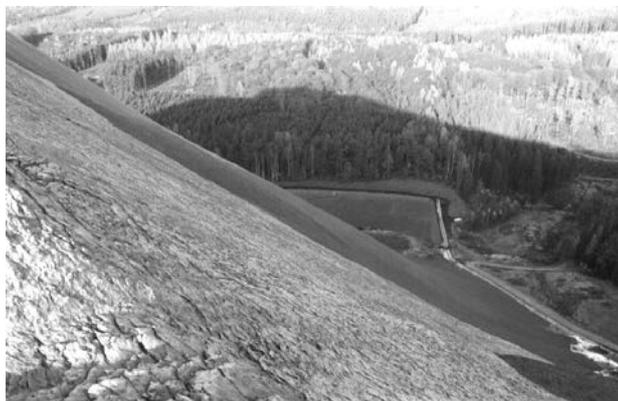
Fig. 9: View from the western slope

Working on the slope was considered practically impossible (fig. 9). Due to the very high forces, supporting structures such as retaining walls,

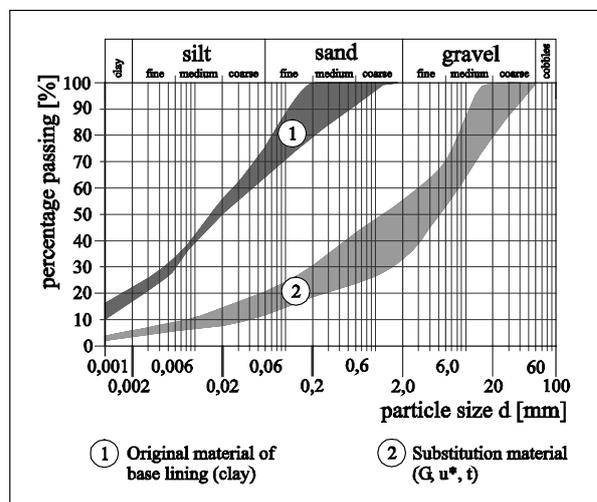
Fig. 10: Grain-size distribution of original base lining and substitution material of weathered basaltic rock “Steinerde”

Six months after the movements had been observed first, the basic clay lining was exchanged by a material of weathered basaltic rock called “Steinerde”, which overexceeded the requirements. Its grain size distribution is close to the Fuller-Curve (fig. 11) with a reasonable part of silt and clay.

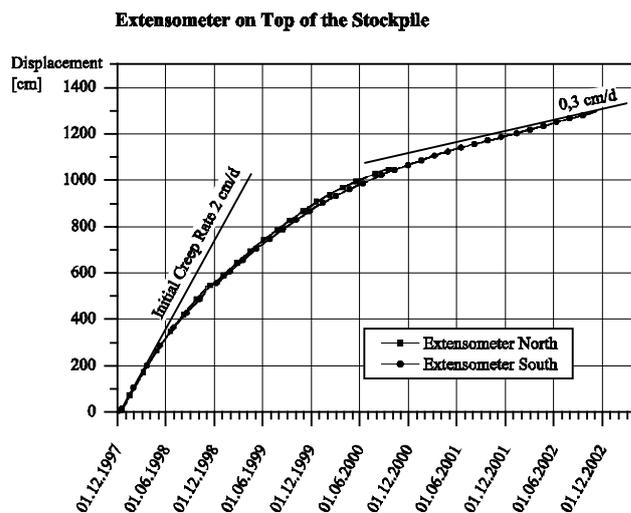
Fig. 11: Displacements measured with Extensometer

The chosen concept proved to be successful as the observed movements indicated by the extenso-

meter show (fig. 12). Within 6 years the movement rates have decreased by the factor greater than 6 to 0,3 cm/d or approximately 1 m/a.

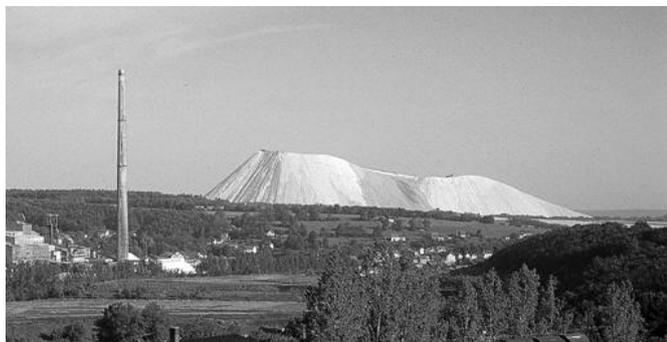
Fig. 13: View on the tailing heap

In the second case history the deformations of a high pressure gas pipeline are presented and discussed. The gas pipeline is situated within a distance of less than 25 m at the base of the slope of a heap a 190 m high. A picture of the heap is shown in fig. 13.

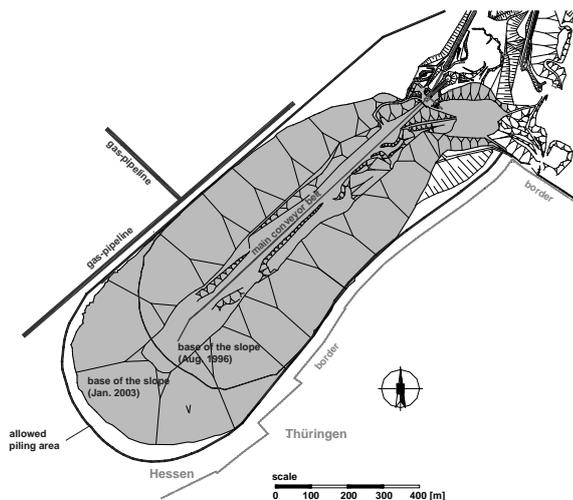
Fig. 14: Ground view of the heap

The base of the heap in figure 15 has the shape of a kidney. The length of the heap in southeast to northwest direction is about 1200 m. The width of the heap from northwest to southeast is 550 m. The gas-pipeline with a soil cover of 1 m and a diameter of 0.35 m passes along the northwest side of the heap (in red, fig. 14).

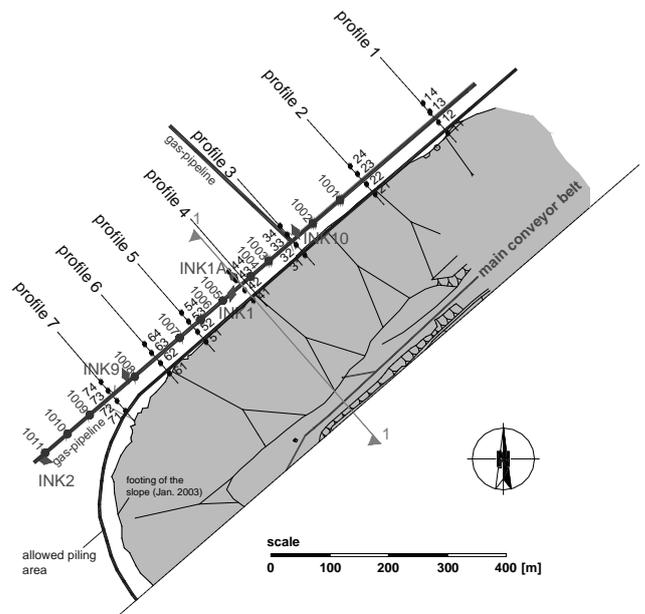
Fig. 15: Ground view (detail) with measuring system

gas-pipeline and the measuring system is shown. According to the Observational Method the horizontal and vertical deformations of the gas pipeline are surveyed by several profiles of geodetic measuring points (profiles 1 to 7, fig. 15) and by inclinometers placed along the side of the tailing heap within a distance from 10 m up to 50 m (INK 1 to INK 10). The inclinometers have a depth of 30 m.

Furthermore a profile of points in along the baseline of the slope is measured geodetically (points 1001 to 1019).

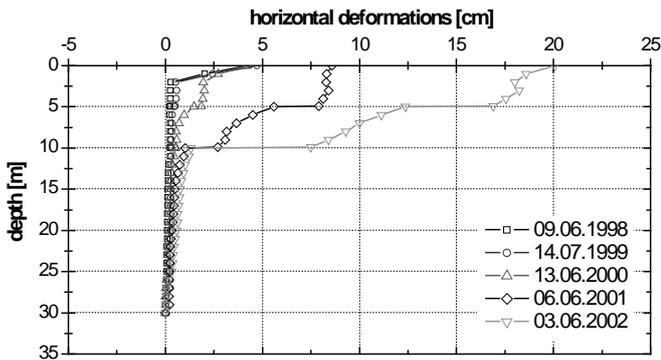
Fig. 16: Horizontal deformations measured in INK 1

In figure 16 some measuring results from the inclinometer INK 1 until the year 2002 are shown.

The inclinometer shows the two natural slip surfaces in depths of 5 and 10 m.

In figure 20 the calculated time dependent deformations are shown. Based on the measured deformations between June 2000 and May 2002 in INK 1 (fig. 16) the deformations in this time step were calculated as an back analysis using the above mentioned angles of friction in the natural slip-surfaces. The calculated long term deformation rate is shown in figure 20 with an constant value of about 4 cm/a. This result fits quite well with the measured horizontal deformations in figure 17 where between March 2004 and March 2005 in point 1005 nearly 5 cm occurred.

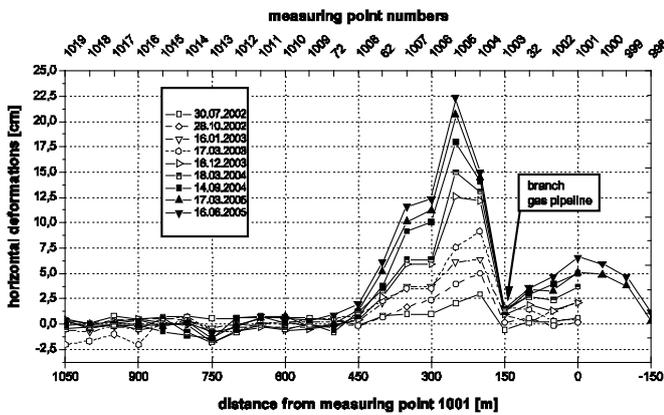
Fig. 17: Horizontal deformations along the baseline of the slope

Having a look at the horizontal deformations along the baseline of the slope in the points 1001 up to 1011 (fig. 17) the localization of the deformations can be noticed. The maximum of the differential deformations is noted between the points no. 1003 and 1004. The horizontal extension of the moving part of the subsoil parallel to the baseline of the slope can be estimated to approximately 300 m.

Up to now the maximum differential horizontal deformations between two measuring points (1003, 1004 s. fig. 17) reaches roughly 13,5 cm. To consider the deformations along the gas pipeline which not has been measured before July 2002 an additional differential horizontal deformation of 10 cm is add on the measured values. From this follows a maximum total

differential horizontal deformation of 23,5 cm between the points 1003 and 1004. This value is underlying the evaluation of the serviceability of the gas pipeline. So nearly 40 % of the allowed maximum differential horizontal deformation of the gas pipeline within a distance of 50 m occurred right now.

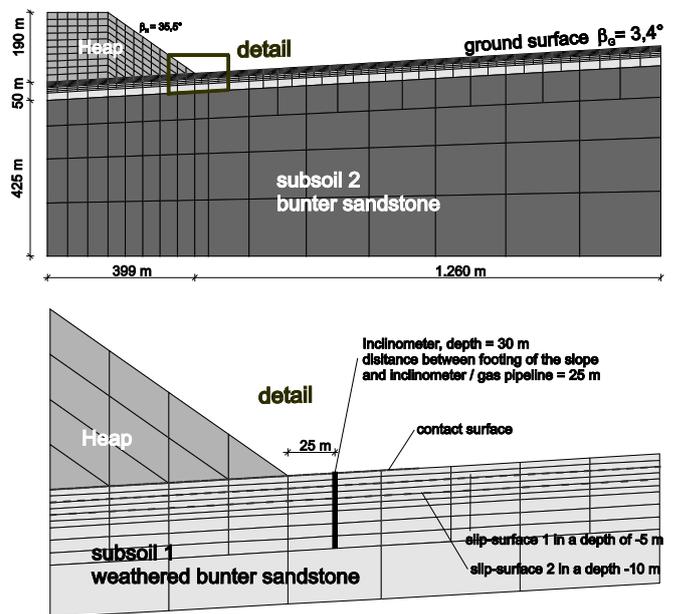
Fig. 18: Finite-Element-Model of the heap

The discretization of the Finite-Element-Model is shown in figure 18. Viscoplastic material behaviour for the salt has been considered using the constitutive equations of Boley (1999). Bunter Sandstone and weathered Bunter Sandstone are modelled using elasto-plastic material behaviour. The slip surfaces in a depth of 5 m and 10 m are modelled as contact pairs using the master-slave-concept to allow large deformations.

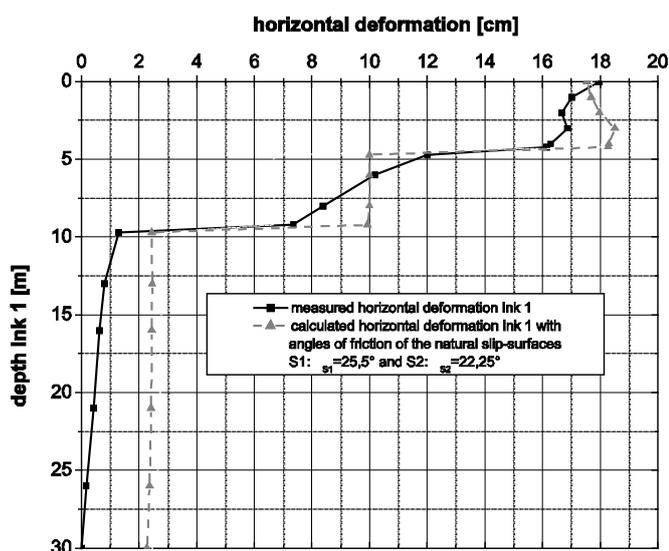
Fig. 19: Results of the back-analysis

With the calibrated model numerical simulations for an improved forecast of the expected deformation have been executed. Fig. 19 shows the comparison between measured and calculated horizontal displacements in inclinometer Ink 1. The angles of friction ϕ_s in the slip-surfaces (S1, S2) have been back calculated. Both curves correspond well.
